## **Appendix A: Historic and Current Photographs of Merrimack Village Dam and its Surroundings**

- **Historic Photos (Photos 1-10),**
- **2/22/03 (Photos 11-15),**
- **6/12/03 (Photos 16-19),**
- **10/20/03 (Photos 20-25),**
- **6/3/04 (Photos 26-28),**
- **6/29/04 (Photos 29-36),**
- **6/30/04 (Photos 37-39),**
- **10/27/04 (Photos 40-44).**

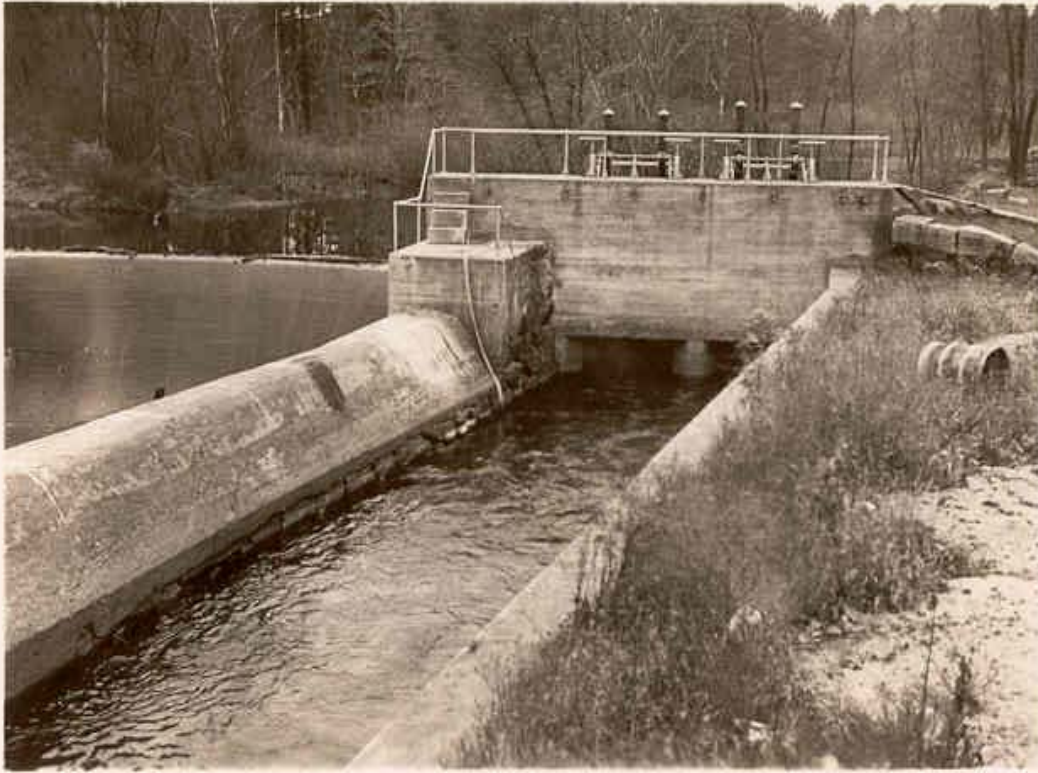
Photo No.: 1, Date: 1934, Courtesy NHDES, Dam Safety

Description: Looking at left power canal, canal is functional for passing water

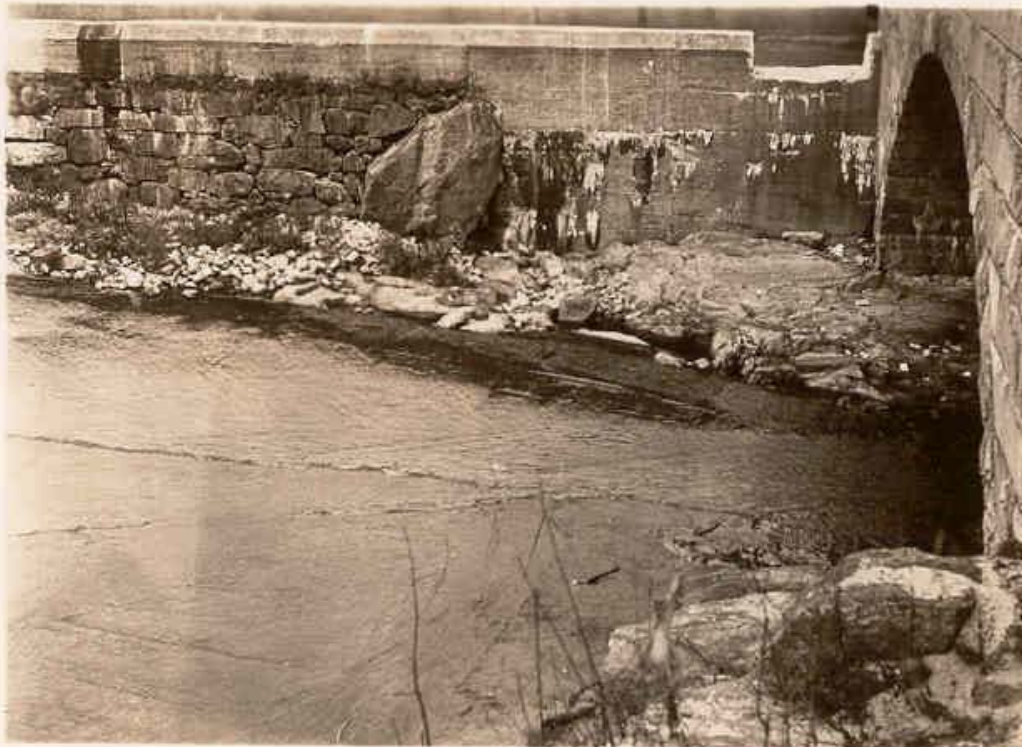
Photo No.: 2, Date: 1934, Courtesy NHDES, Dam Safety

Description: Looking at apron and front of Chamberlain Bridge

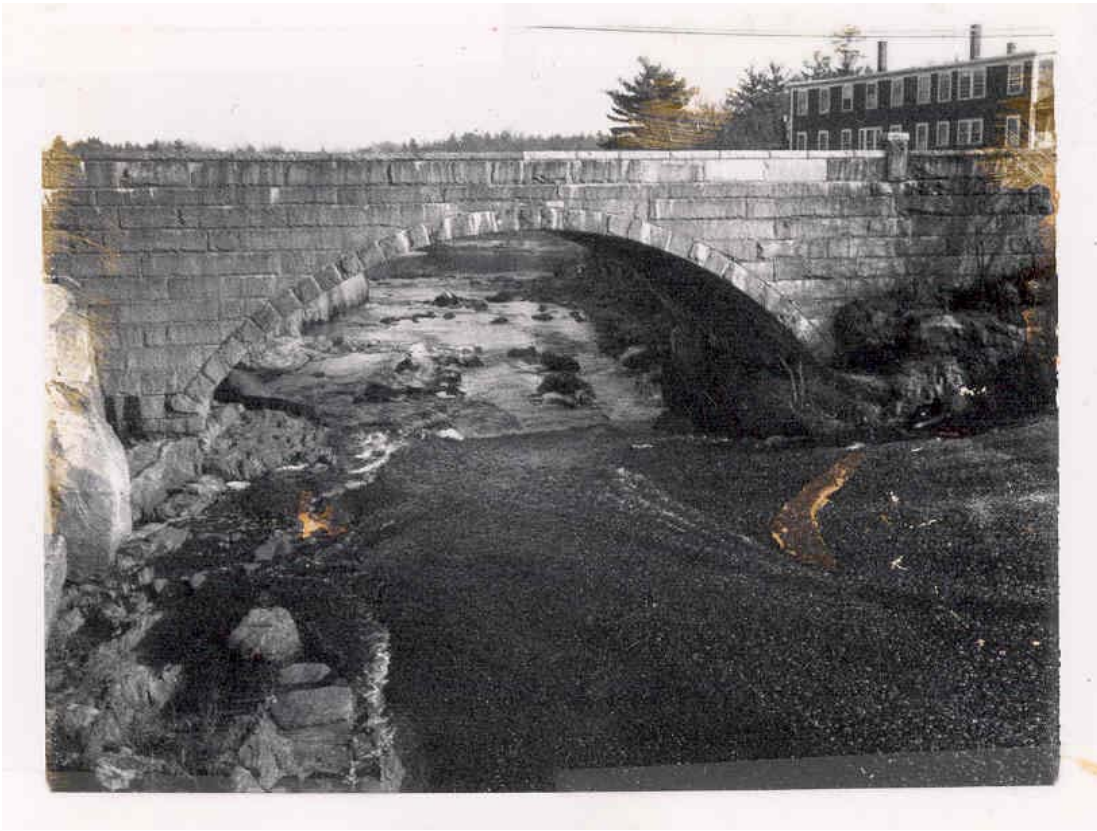
Photo No.:7, Date: 1975, Courtesy NHDES, Dam Safety  
 Description: Looking downstream at Chamberlain Bridge

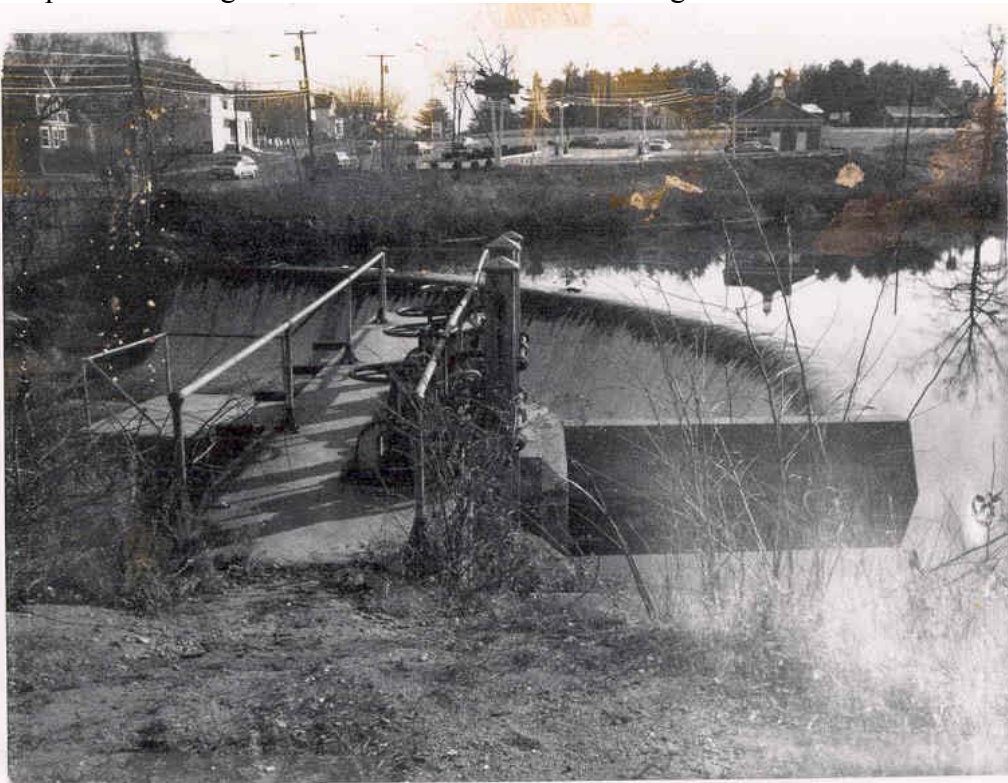
Photo No.:8, Date: 1975, Courtesy NHDES, Dam Safety  
 Description: Looking across dam from left abutment

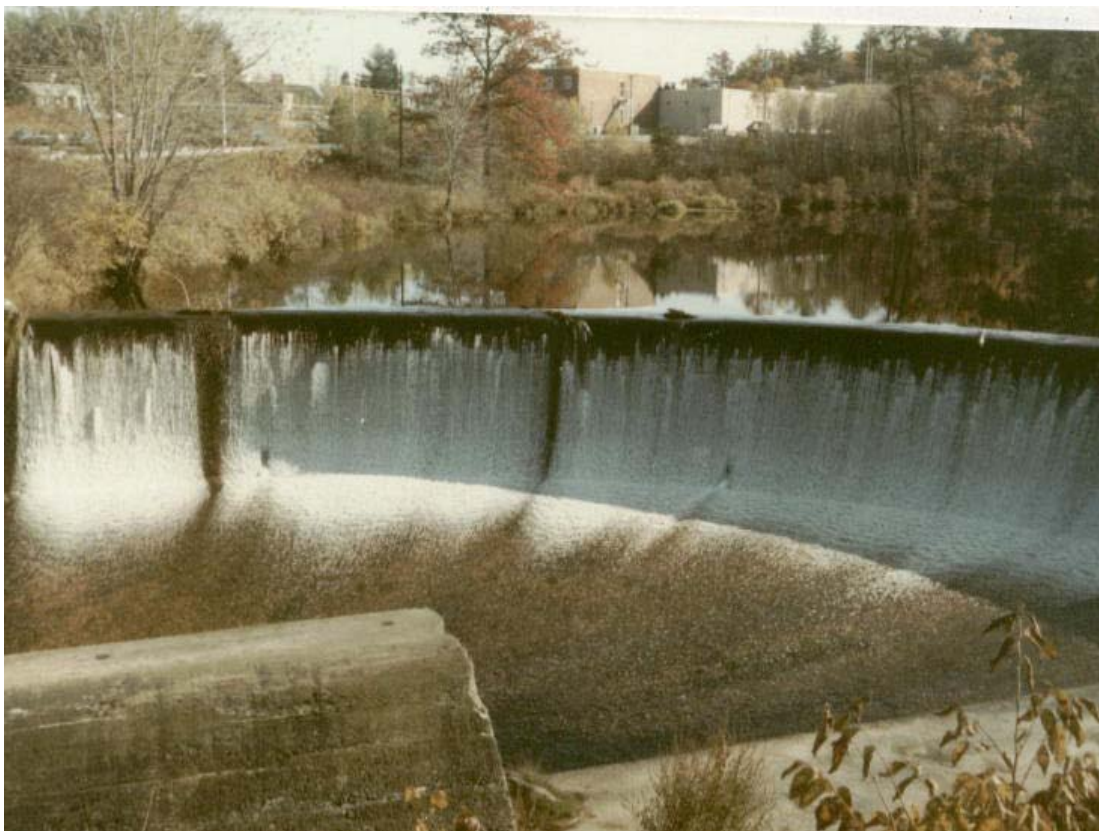
Photo No.:9, Date: 1982, Courtesy NHDES, Dam Safety  
Description: Looking at spillway section of dam

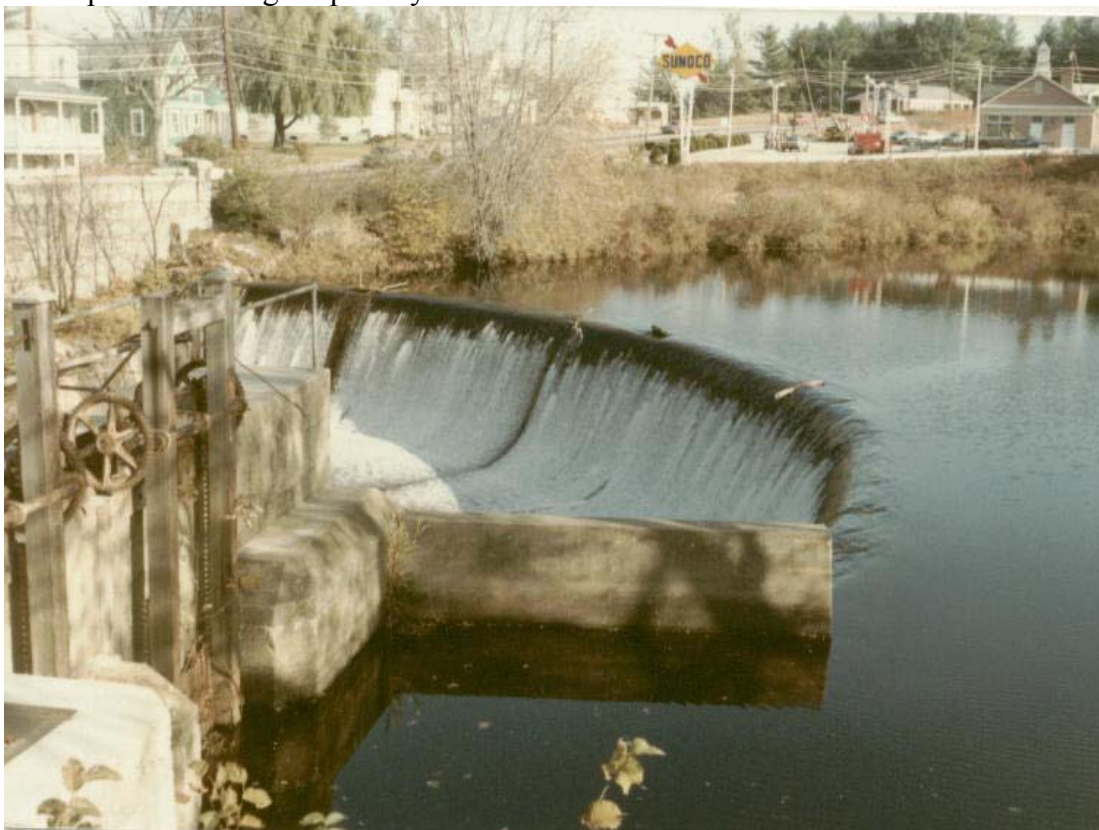
Photo No.:10, Date: 1985, Courtesy NHDES, Dam Safety  
Description: Looking at spillway from left abutment

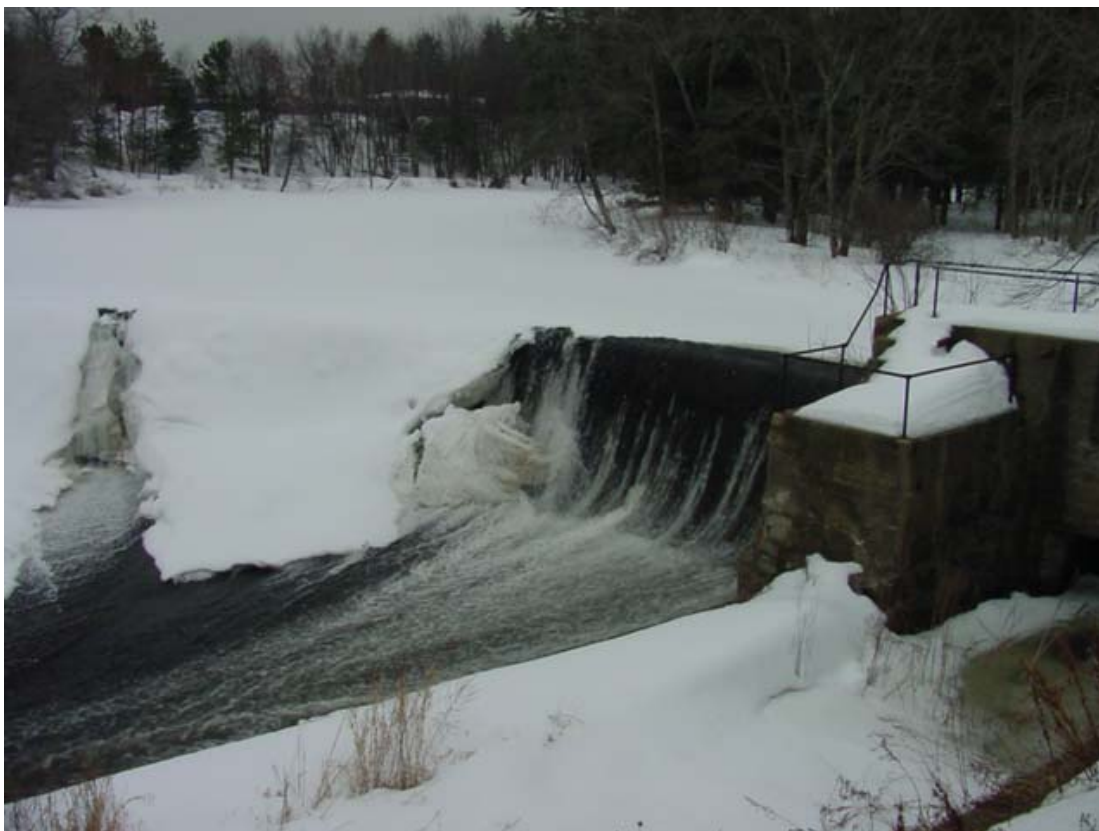
Photo No.: 11, Date: 2/22/03, Mean Flow at Souhegan River Gage: 169 cfs  
Description: Looking at left abutment of Merrimack Village Dam

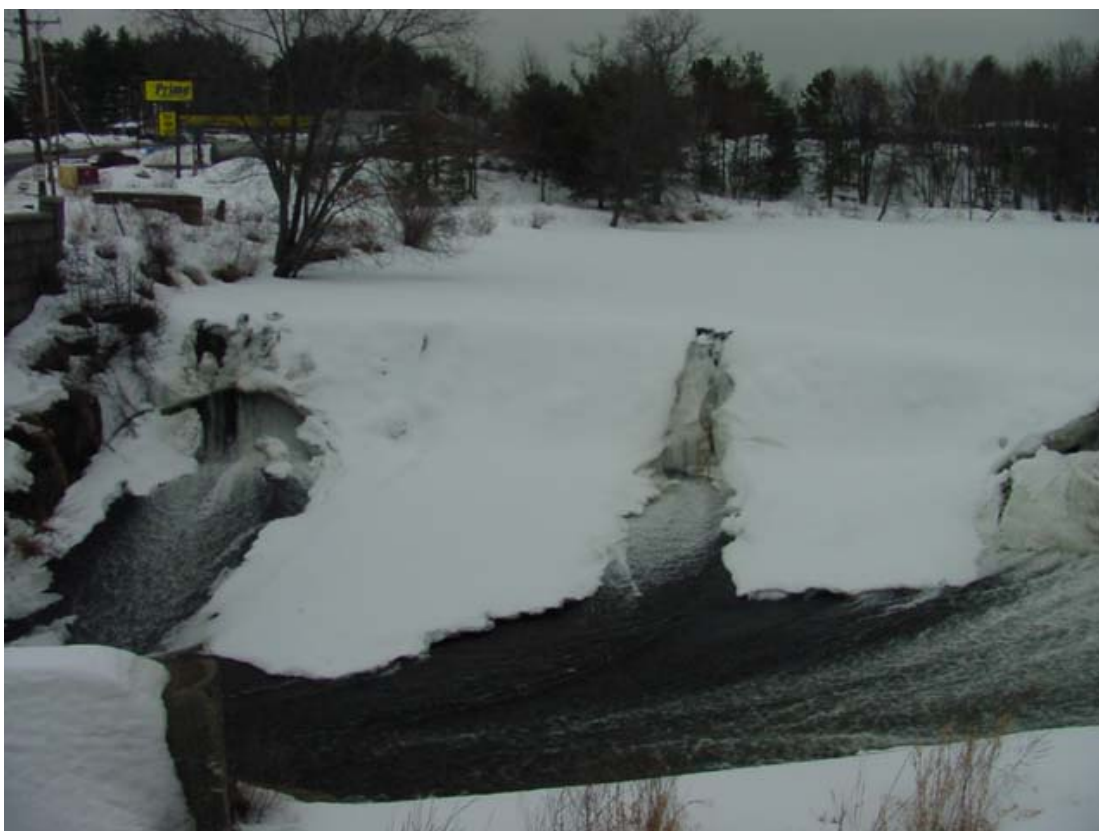
Photo No.: 12, Date: 2/22/03, Mean Flow at Souhegan River Gage: 169 cfs  
Description: Looking at right abutment of Merrimack Village Dam

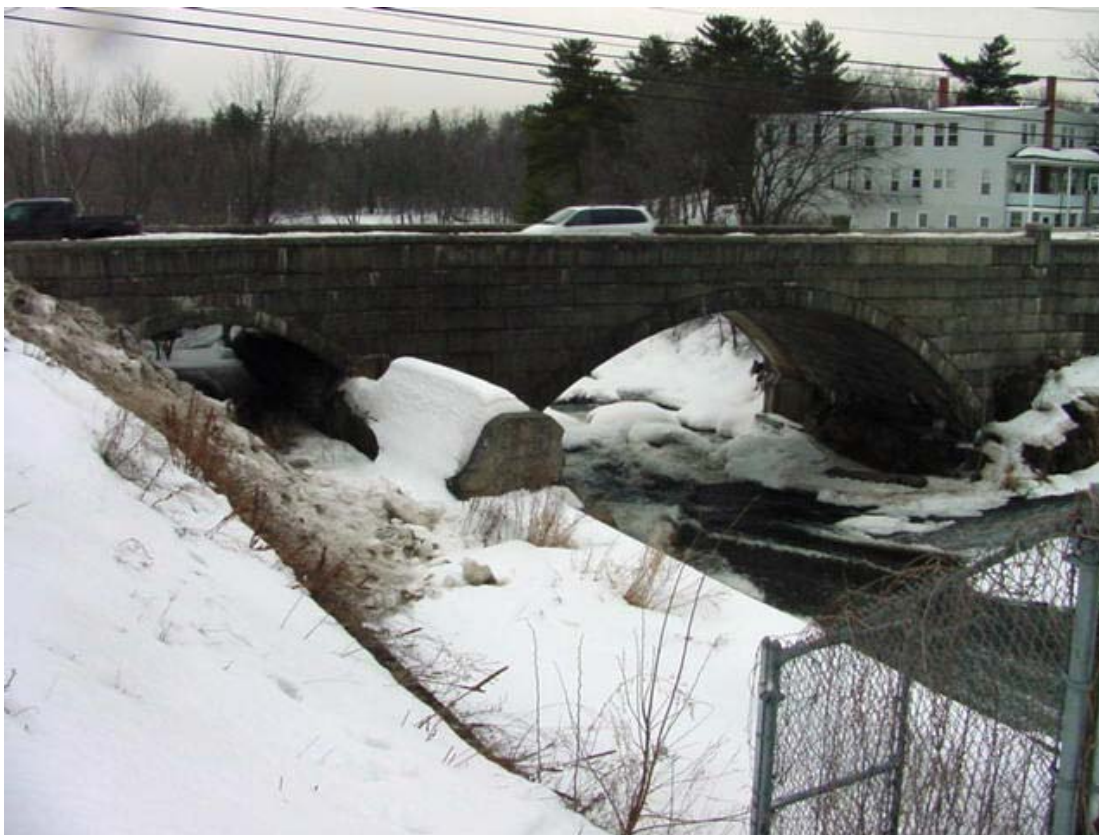
Photo No.: 13, Date: 2/22/03, Mean Flow at Souhegan River Gage: 169 cfs  
Description: Looking downstream at Chamberlain Bridge

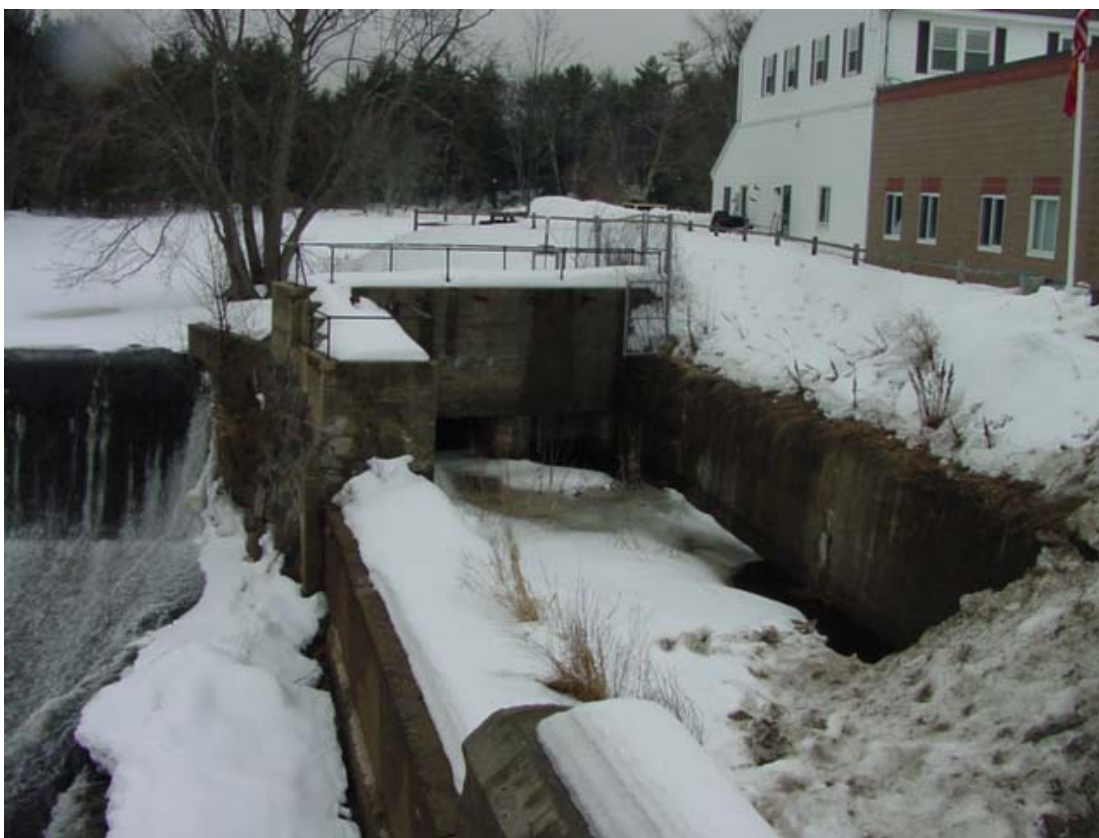
Photo No.: 14, Date: 2/22/03, Mean Flow at Souhegan River Gage: 169 cfs  
Description: Looking at Headgate Structure

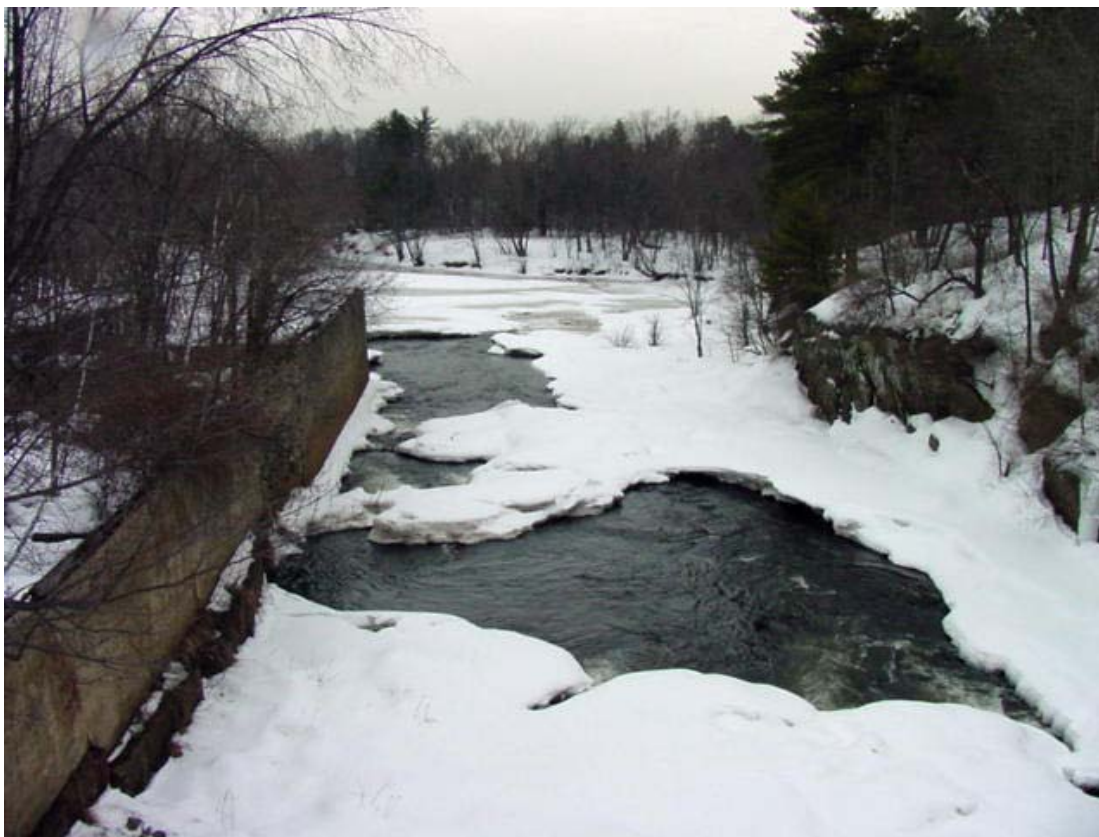
Photo No.: 15, Date: 2/22/03, Mean Flow at Souhegan River Gage: 169 cfs  
Description: Looking downstream from Chamberlain Bridge

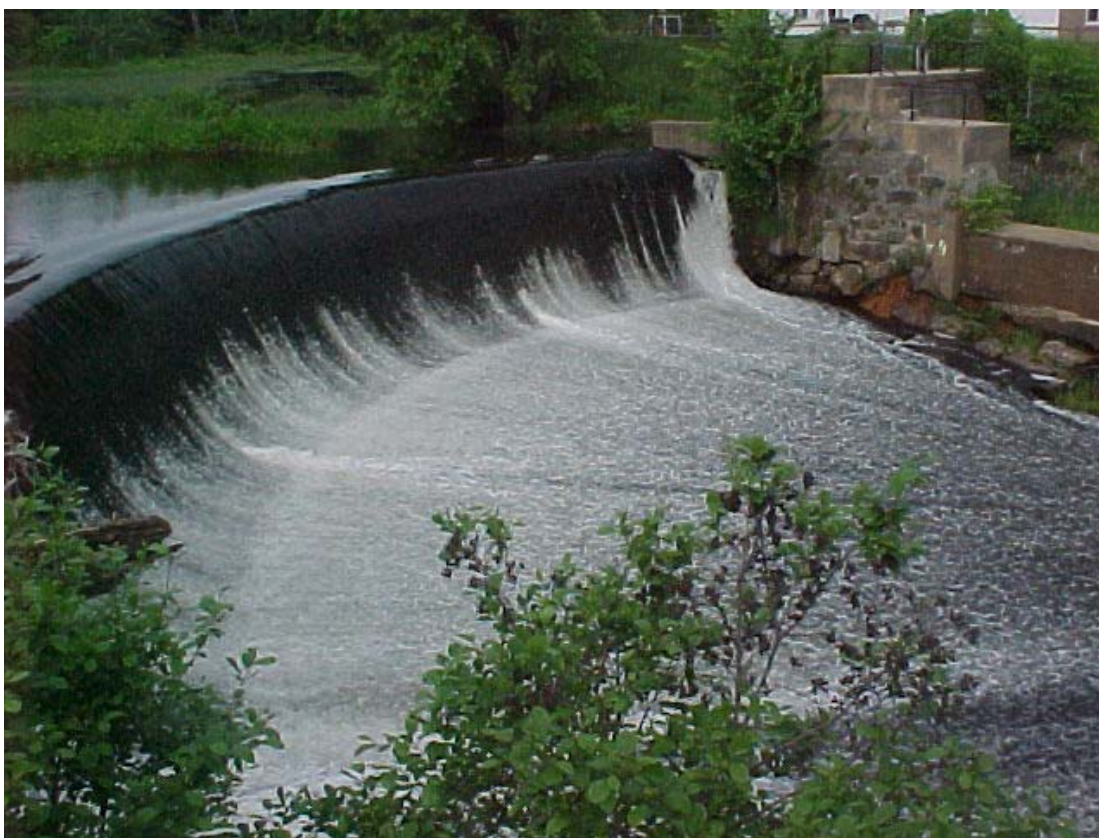
Photo No.: 16, Date: 6/12/03, Mean Flow at Souhegan River Gage: 366 cfs  
Description: Looking at left abutment (gatehouse)

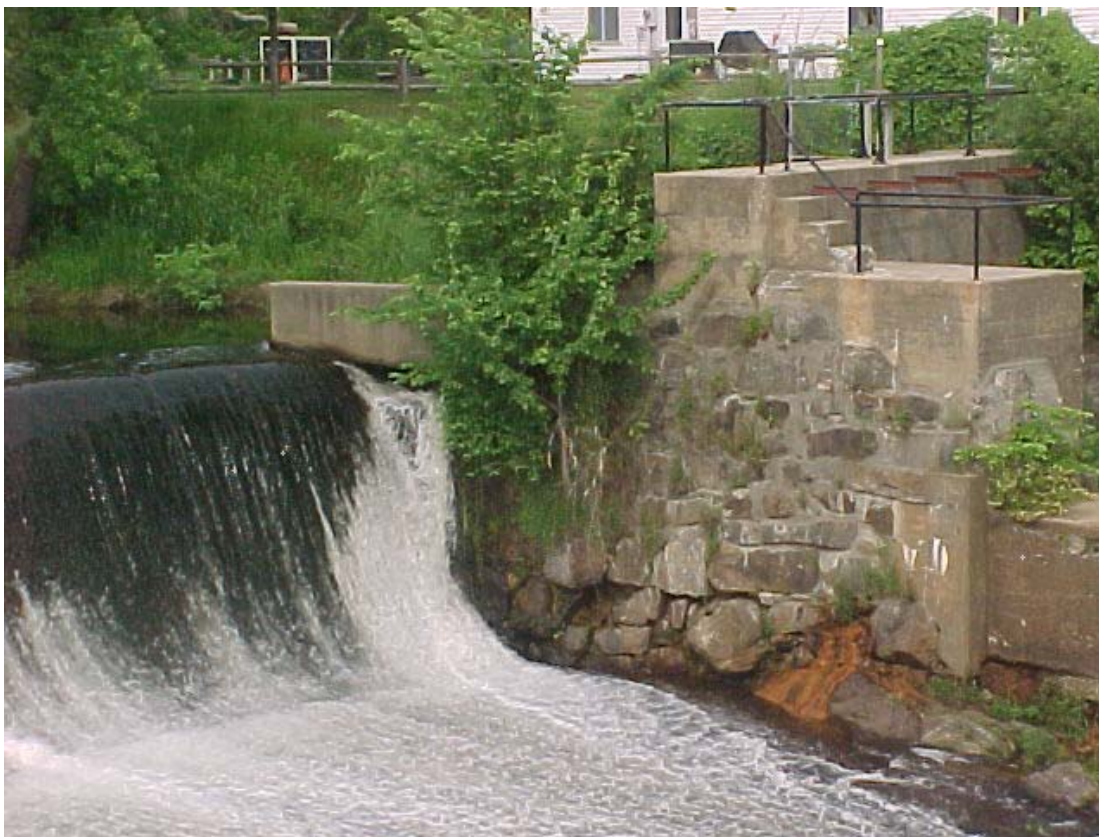
Photo No.: 17, Date: 6/12/03, Mean Flow at Souhegan River Gage: 366 cfs  
Description: Looking at gate structure

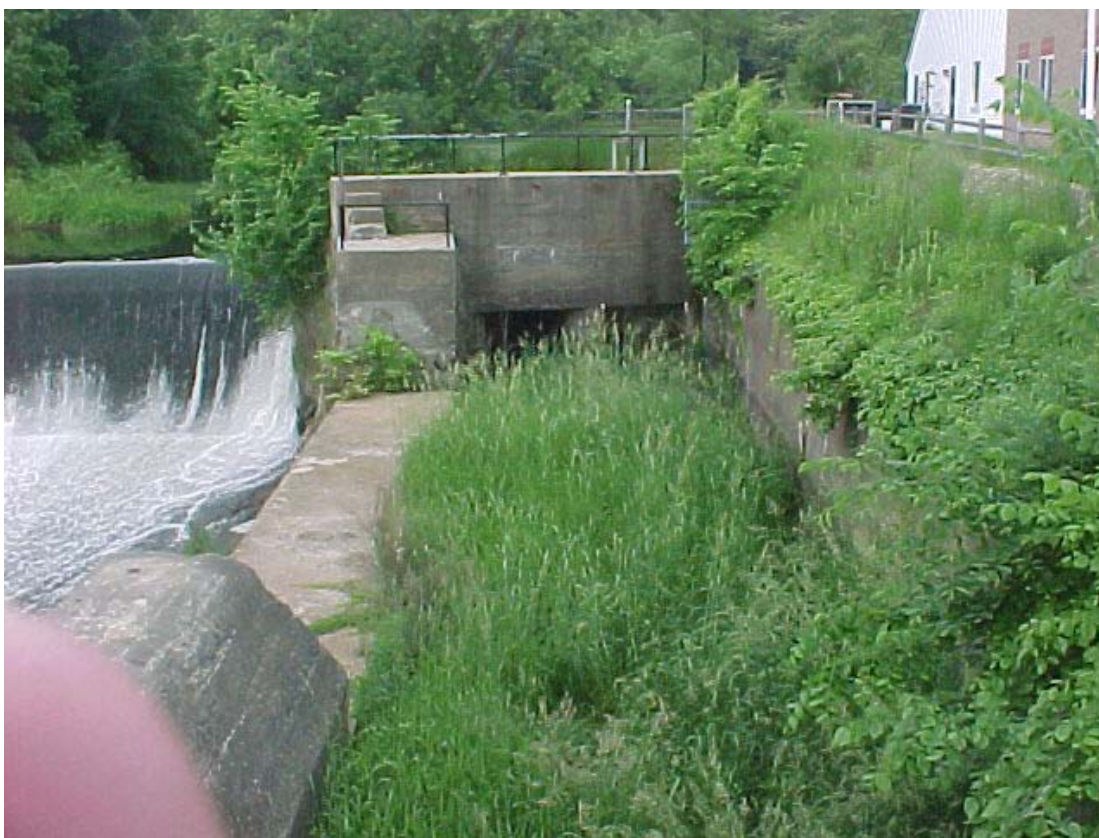
Photo No.: 18, Date: 6/12/03, Mean Flow at Souhegan River Gage: 366 cfs  
Description: Looking in sediment-filled canal

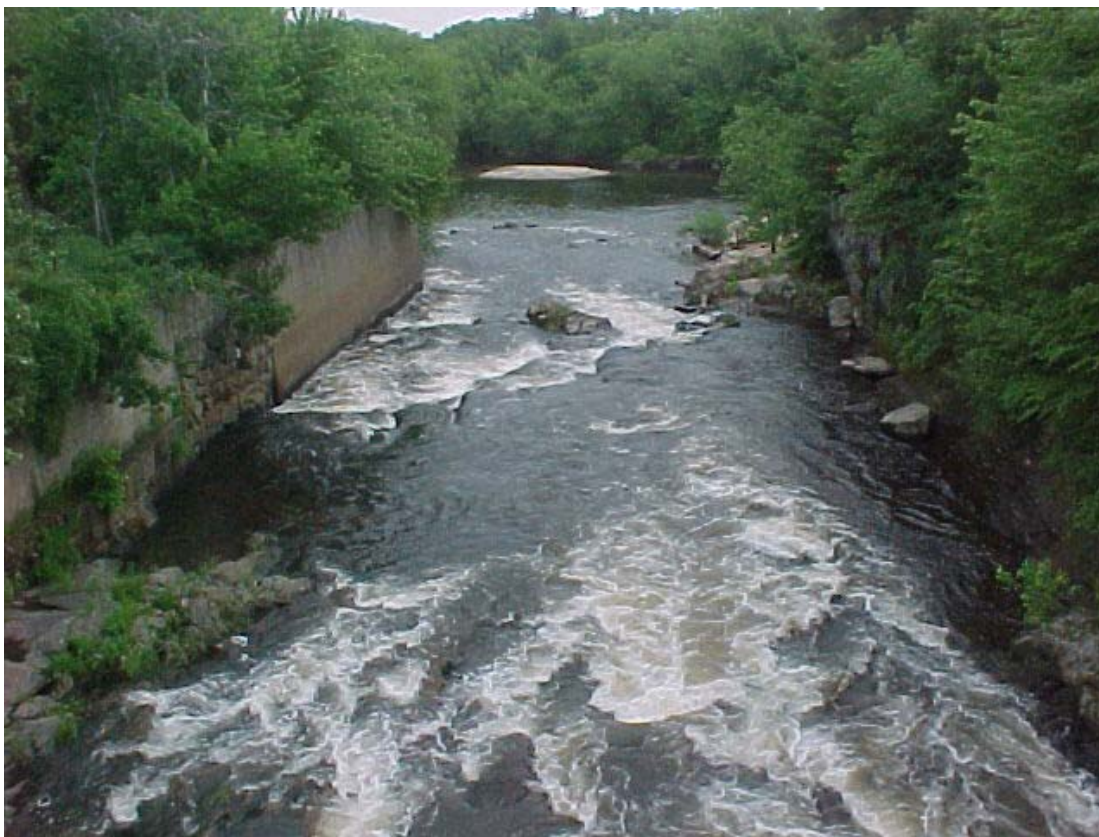
Photo No.: 19, Date: 6/12/03, Mean Flow at Souhegan River Gage: 366 cfs  
Description: Looking downstream from Chamberlain Bridge

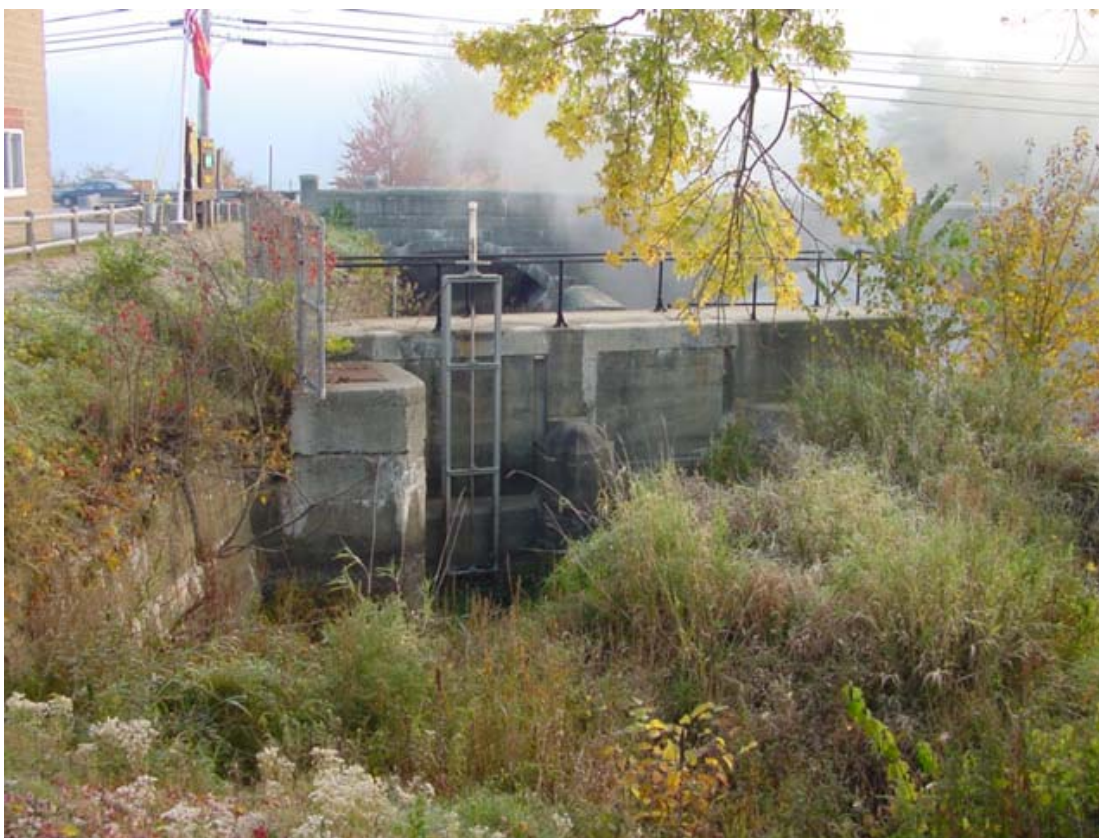
Photo No.: 20, Date: 10/20/03, Mean Flow at Souhegan River Gage: 155 cfs  
Description: Looking at front of gate structure

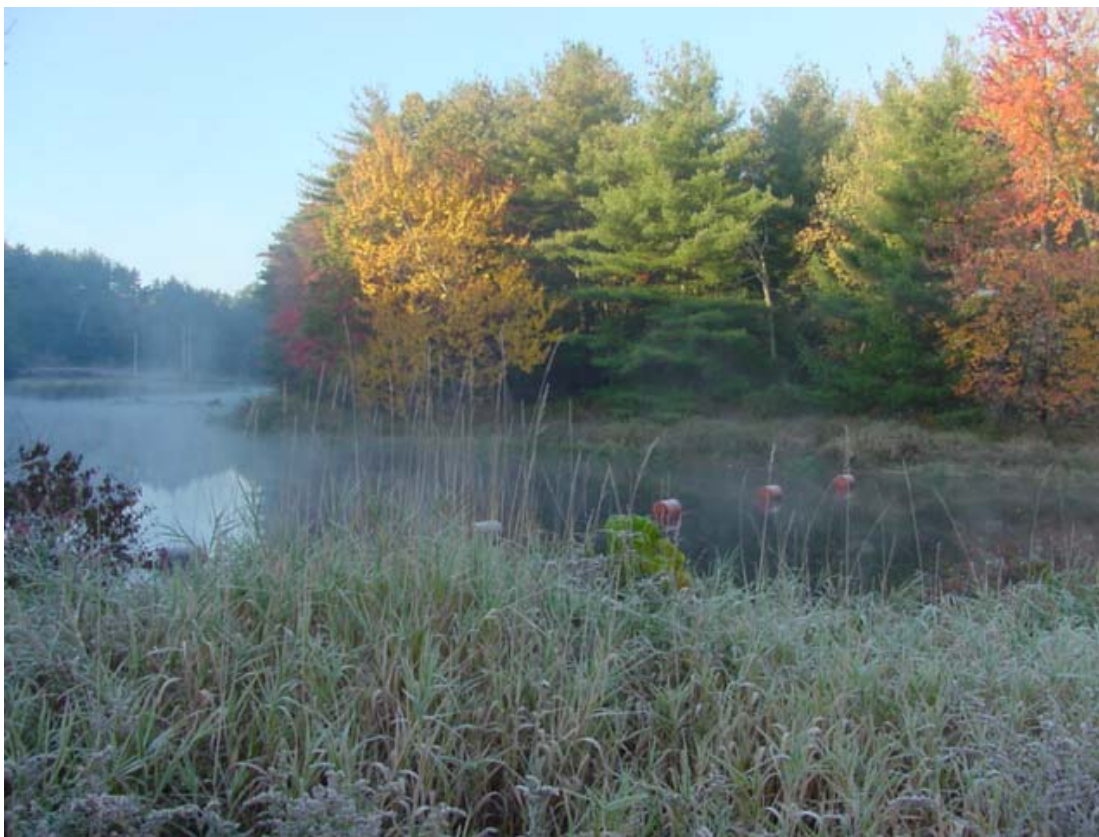
Photo No.: 21, Date: 10/20/03, Mean Flow at Souhegan River Gage: 155 cfs  
Description: Looking at boom above dam

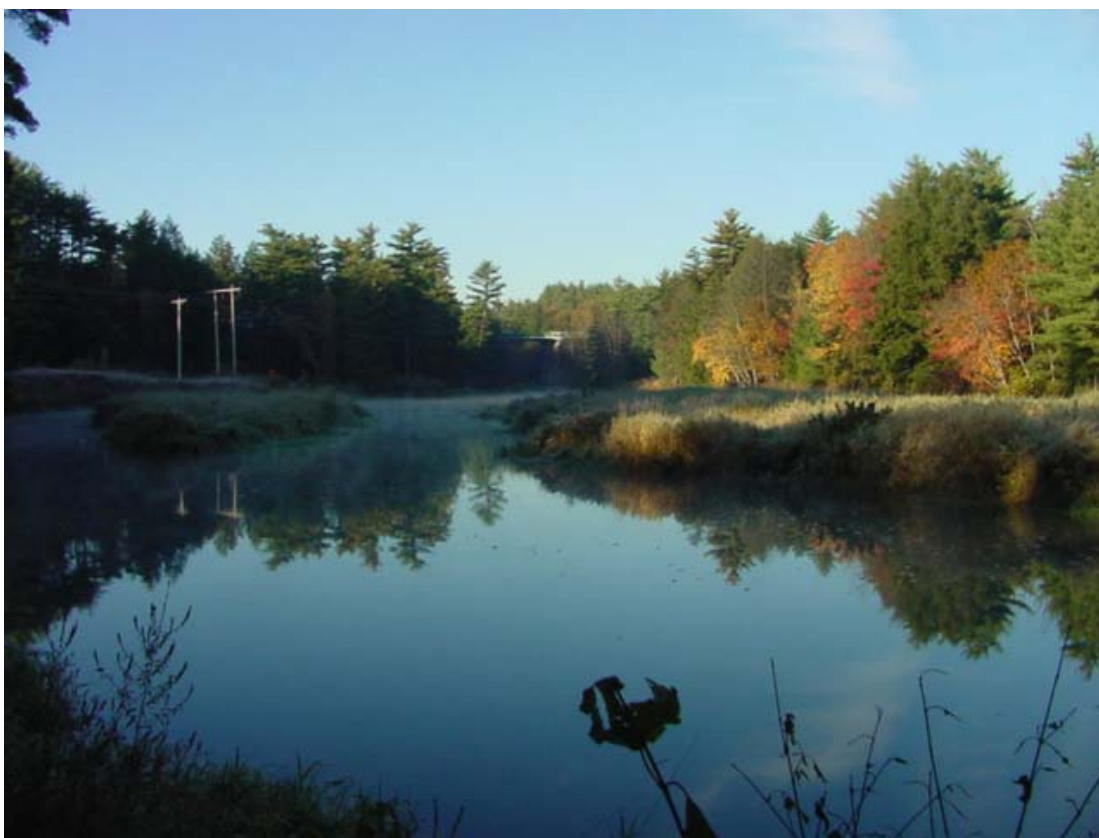
Photo No.: 22, Date: 10/20/03, Mean Flow at Souhegan River Gage: 155 cfs  
Description: Looking upstream in the impoundment

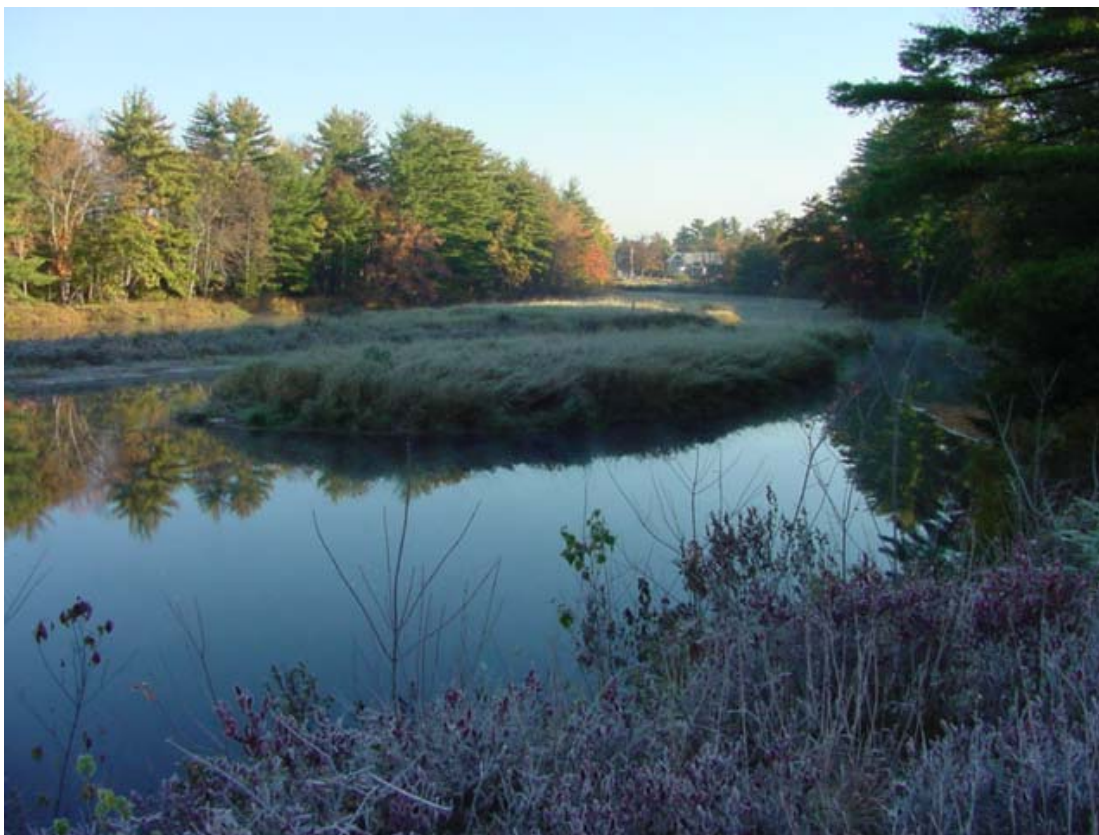
Photo No.: 23, Date: 10/20/03, Mean Flow at Souhegan River Gage: 155 cfs  
Description: Looking downstream at impoundment- two islands shown in foreground

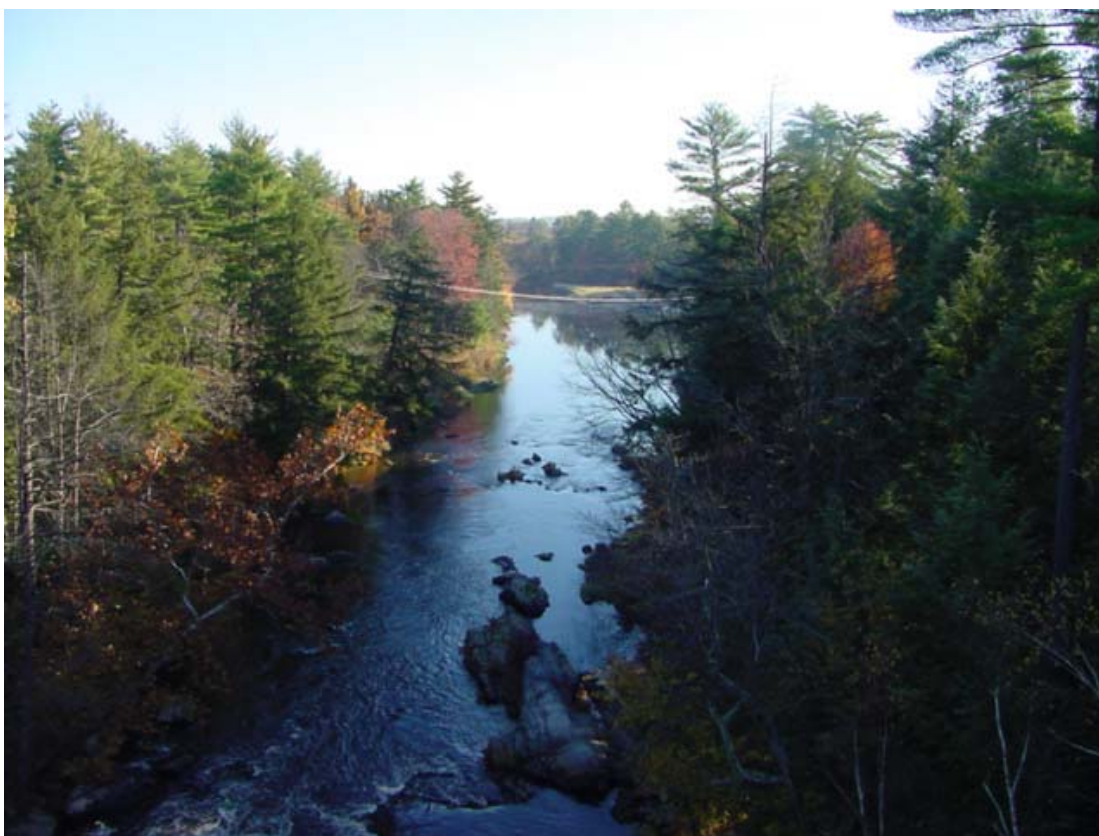
Photo No.: 24, Date: 10/20/03, Mean Flow at Souhegan River Gage: 155 cfs  
Description: Looking downstream from atop Everett Turnpike at impoundment

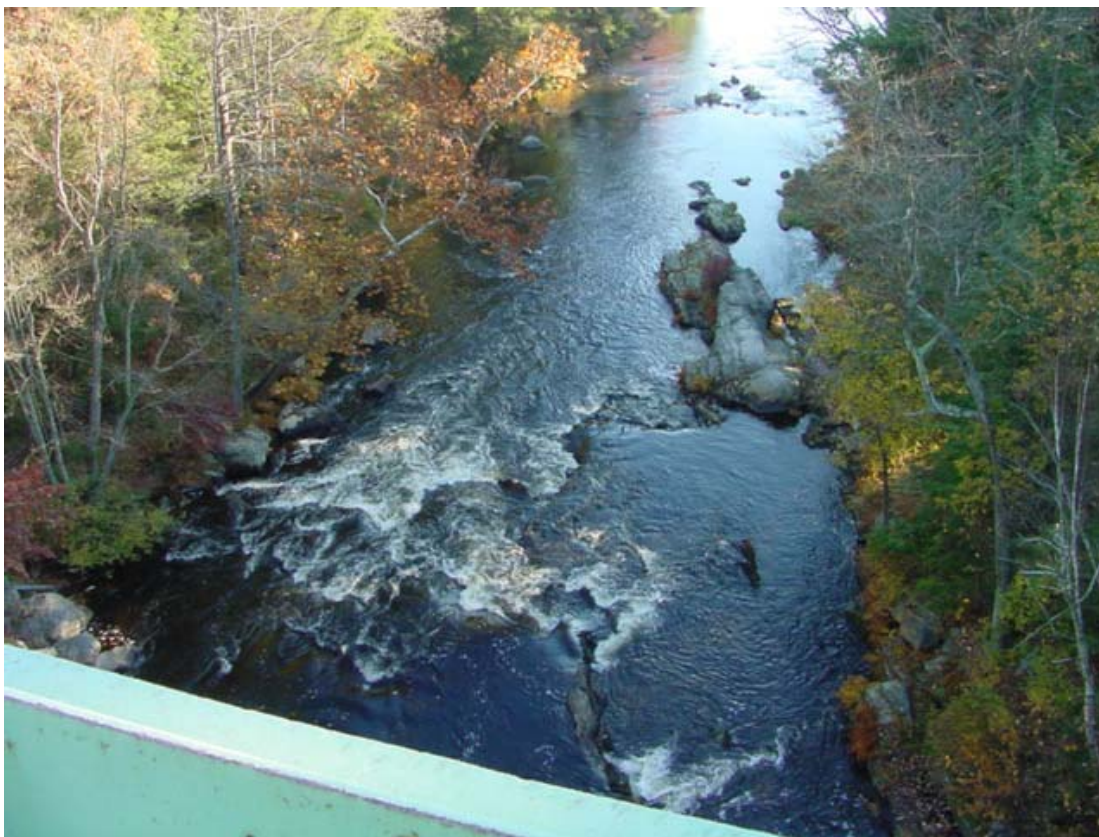
Photo No.: 25, Date: 10/20/03, Mean Flow at Souhegan River Gage: 155 cfs  
Description: Looking directly below Everett Turnpike

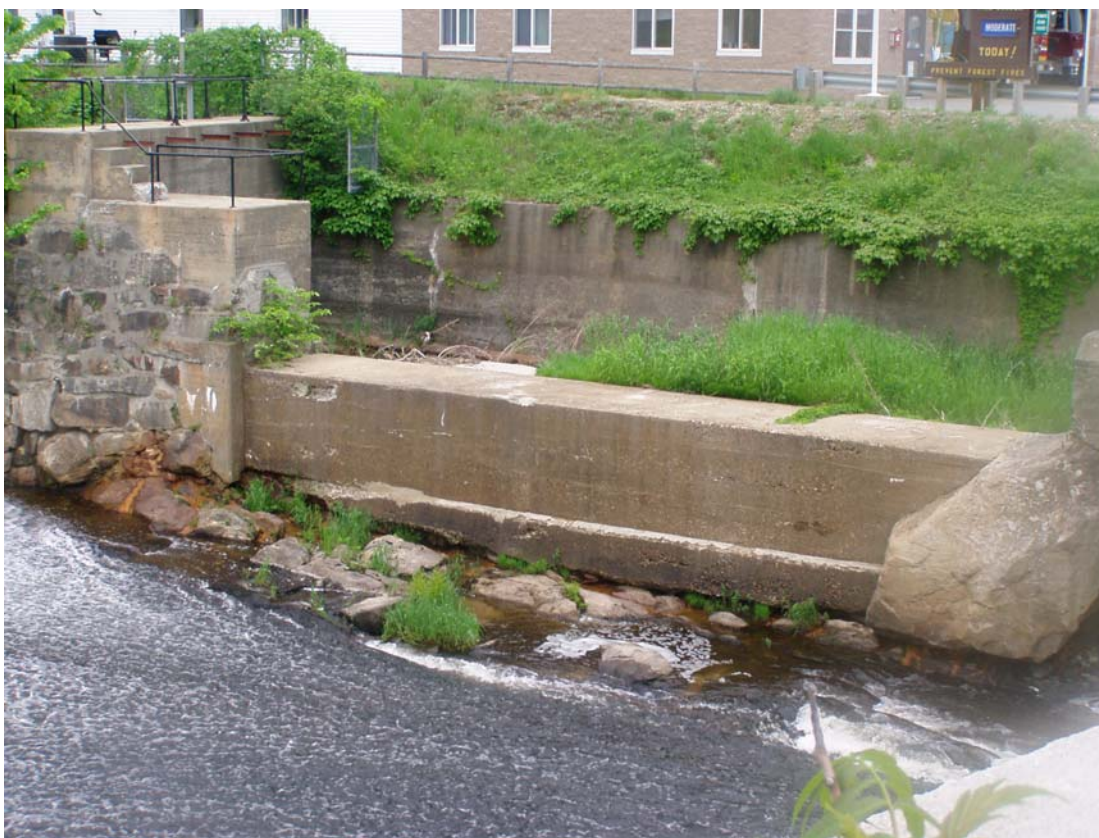
Photo No.: 26, Date: 6/3/04, Mean Flow at Souhegan River Gage: 313 cfs  
Description: Looking at canal, fire department in the background

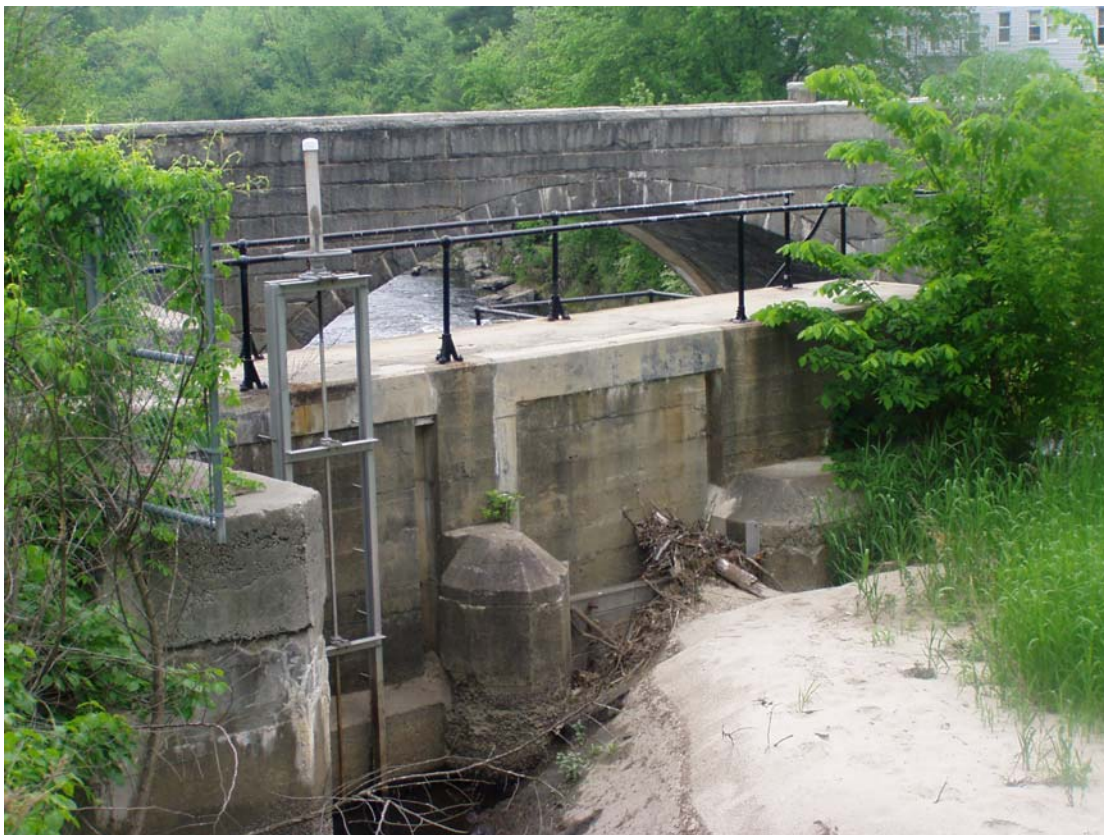
Photo No.: 27, Date: 6/3/04, Mean Flow at Souhegan River Gage: 313 cfs  
Description: Looking at sediment build-up in front of gate

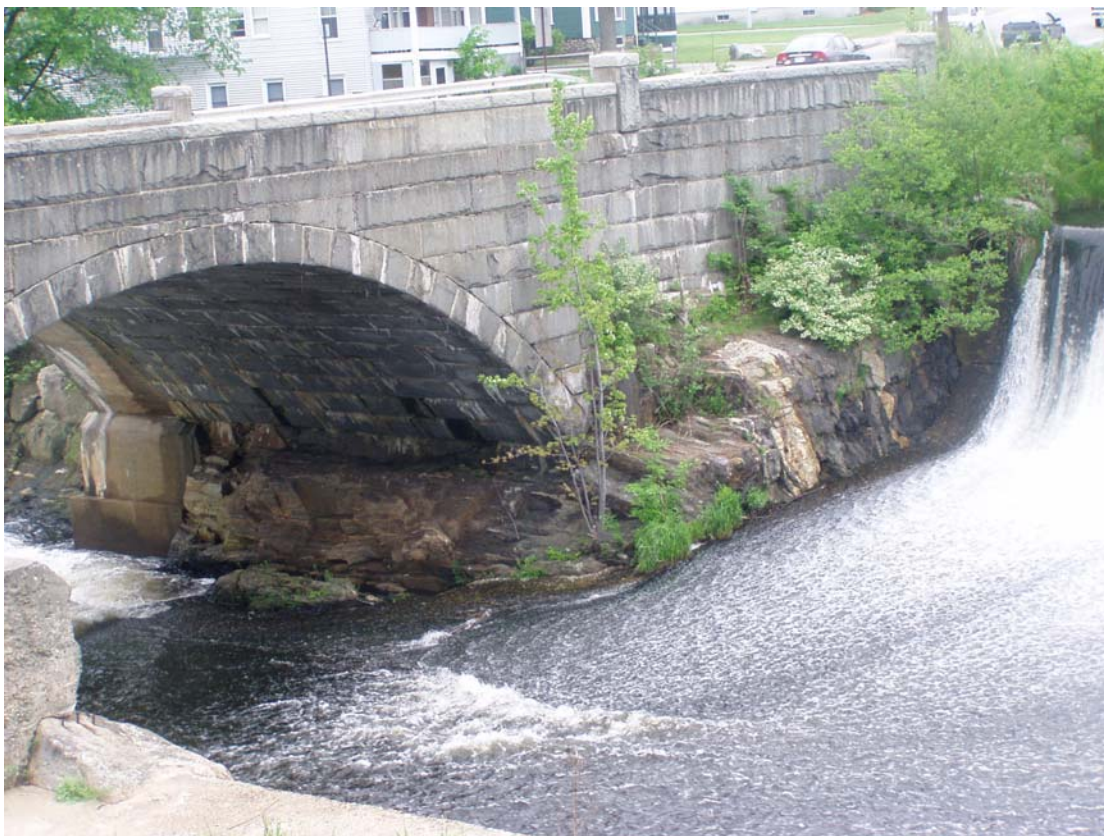
Photo No. 28, Date: 6/3/04, Mean Flow at Souhegan River Gage: 313 cfs  
Description: Looking beneath Chamberlain Bridge at bedrock
